**CENTRAL LIBRARY**

Investigation Report

Central Library Fire  
Los Angeles, California  
April 29, 1986

Michael S. Isner

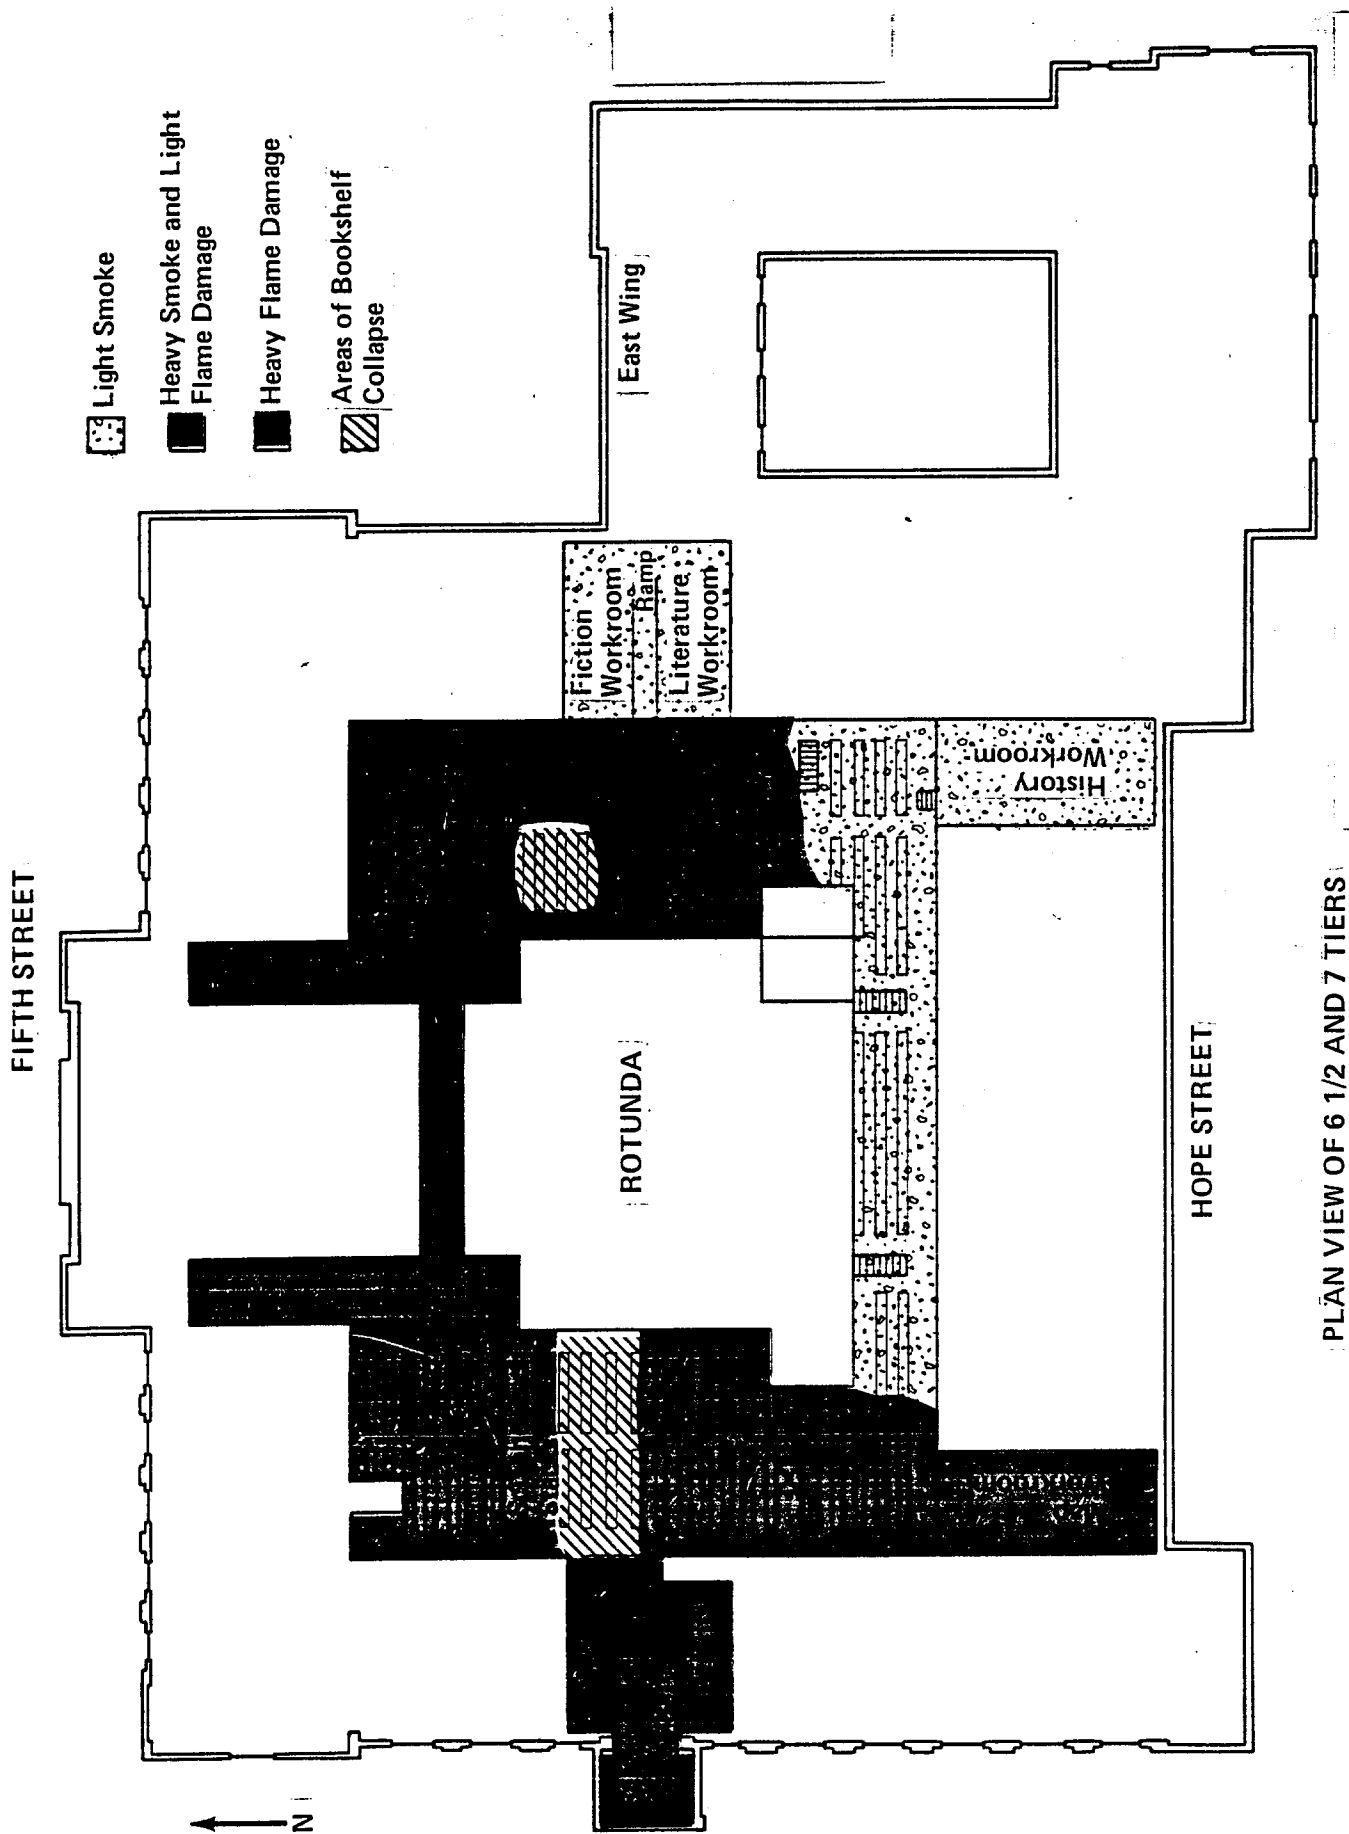
Figure 6

The fire spread up into the tier above. Except for the books in the corner near the stairway (see Figure 6), materials in the 7th tier area directly above the northeast stack were severely damaged by flames or heat. Approximately four rows of bookshelves in this part of the 7th tier collapsed and fell into the 6th tier. The collapse extended only about half the length of the northeast stack.

The fire consumed most material in a dead-end corridor near the northeast stack (see Figure 6). A concrete beam near this corridor had some spalling damage. Only traces remained of the combustible materials that were in the corridor between the northeast and northwest stacks. The 1-inch plaster veneer fell off all surfaces in this corridor and several beams at the west end were severely spalled; a crack in one beam resulted in that member separating from the ceiling/floor slab above. The fire also consumed most combustible materials in the dead-end corridor that was adjacent to the northwest stack (see Figure 6). Once in the northwest stack, the fire caused severe damage and resulted in the collapse of four more rows of bookshelves. This area of collapse, however, extended the full length of the northwest stack (see Photo 4).

The fire involved 7th tier books as far as the southwest stack. The remaining areas of the 7th tier had varying degrees of smoke and heat damage (see Figure 6). Several rooms on the 6 1/2 tier level were damaged by smoke and fire. The Patent Room was gutted (see Photo 5); the Map Room was severely damaged by smoke, and remaining rooms on the 6 1/2 tier received some smoke damage.

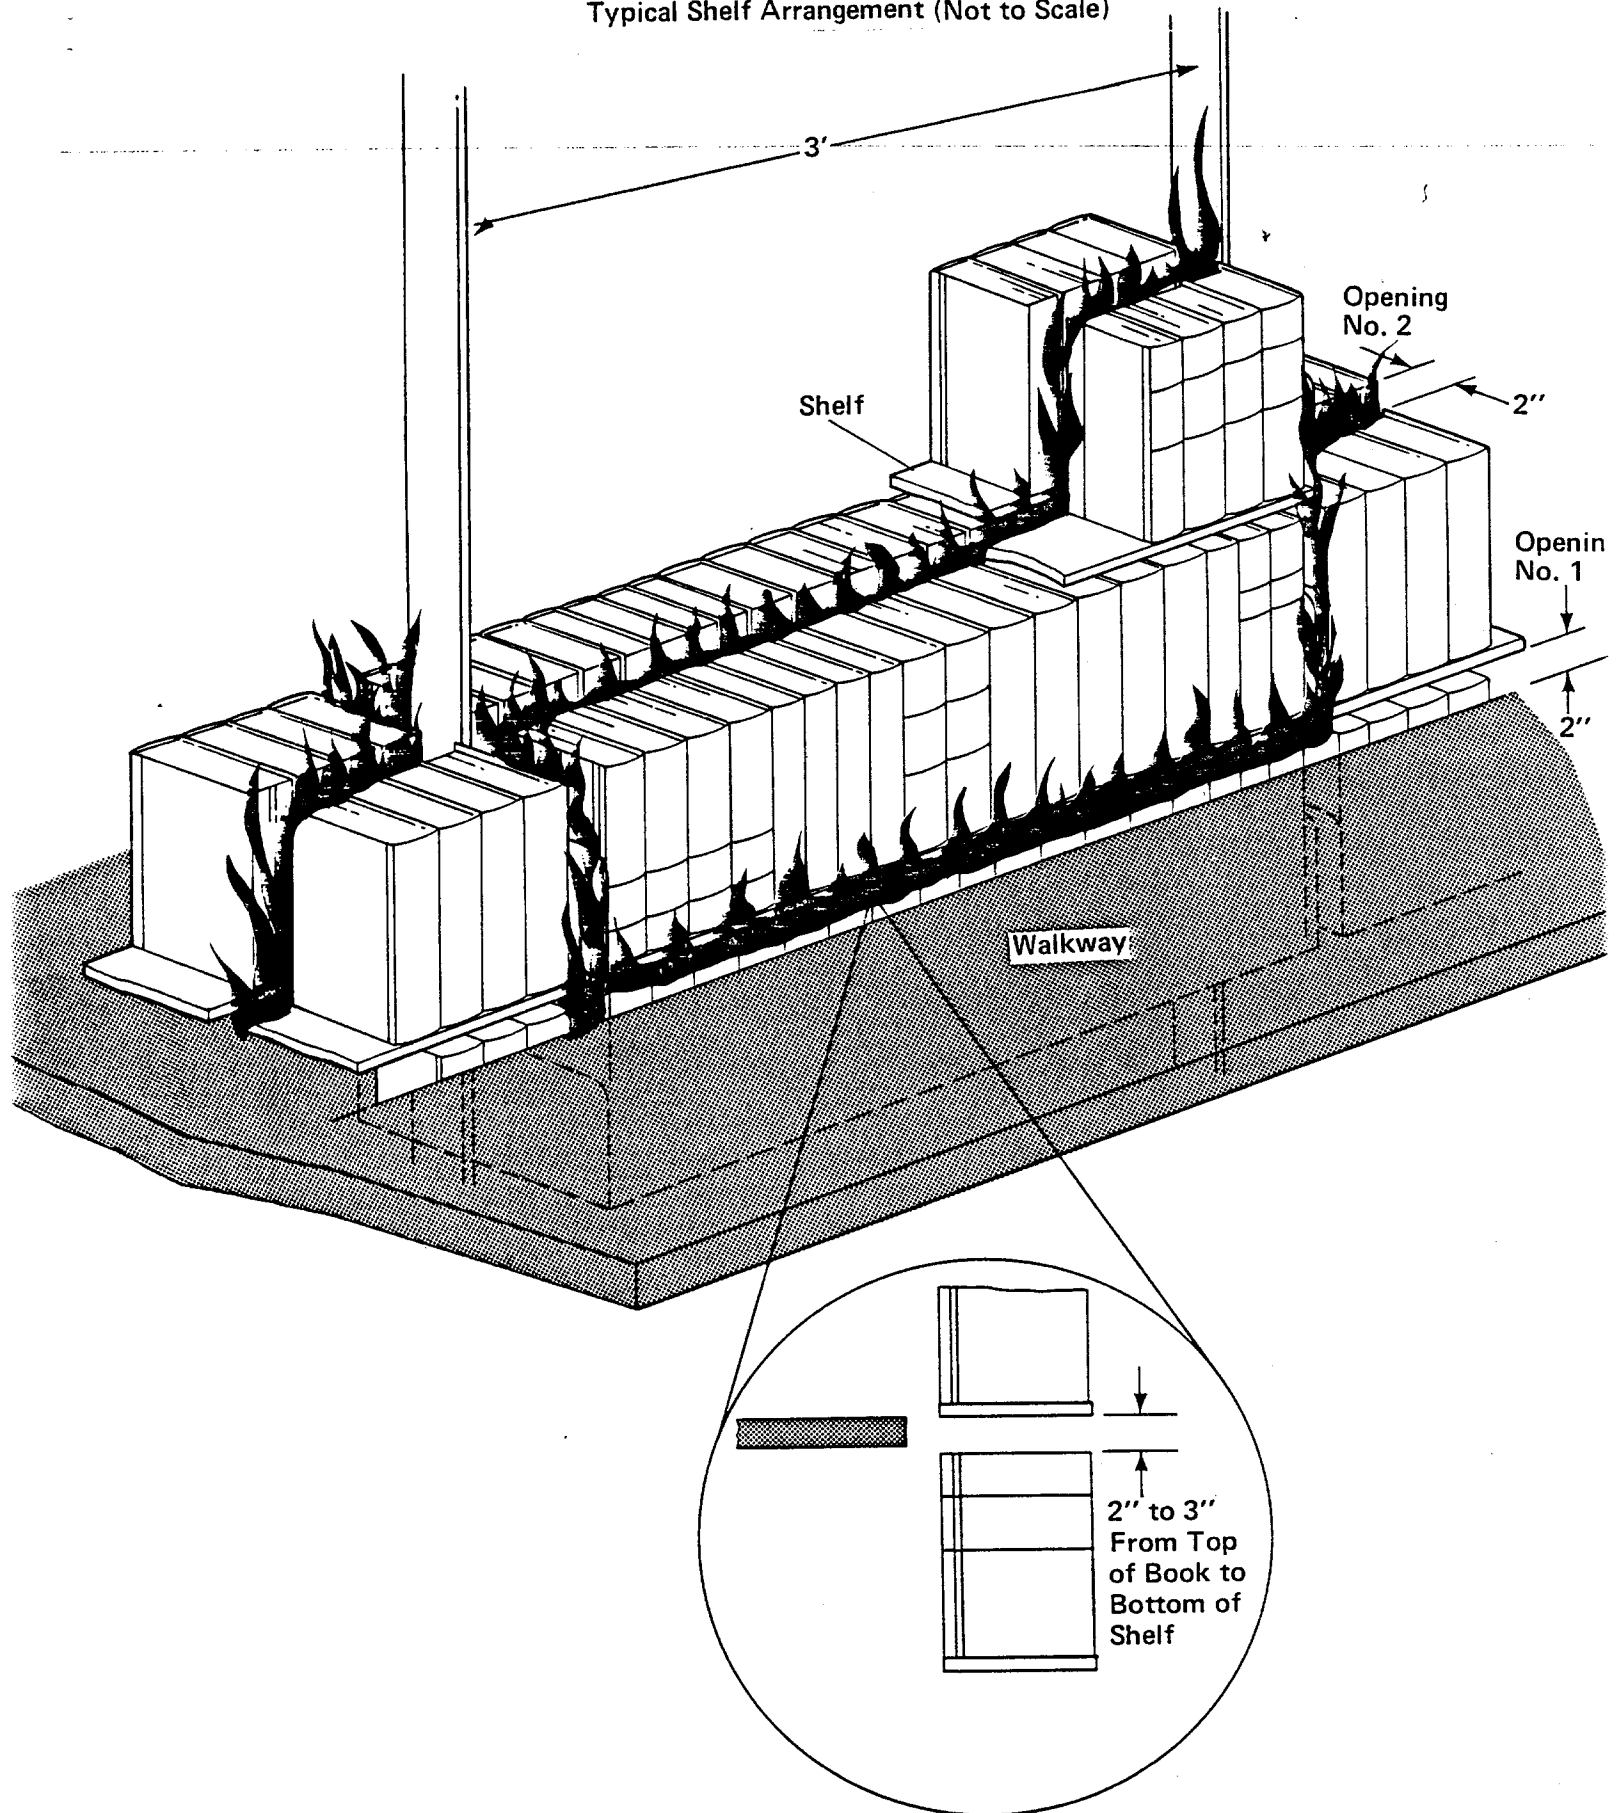
Figure 7 also reveals that a 2-inch space is present between the backs of the bookshelves (opening #2). Like the steel columns, this space is continuous from the basement to the bottom of the third floor slab. The large horizontal opening between shelves at the tier division will allow flames to gain access to the 2-inch vertical opening between shelves. Once in this space, the flames will spread vertically from tier to tier. Since the space is small, radiative feedback between burning surfaces may enhance the fire growth in the space even more.

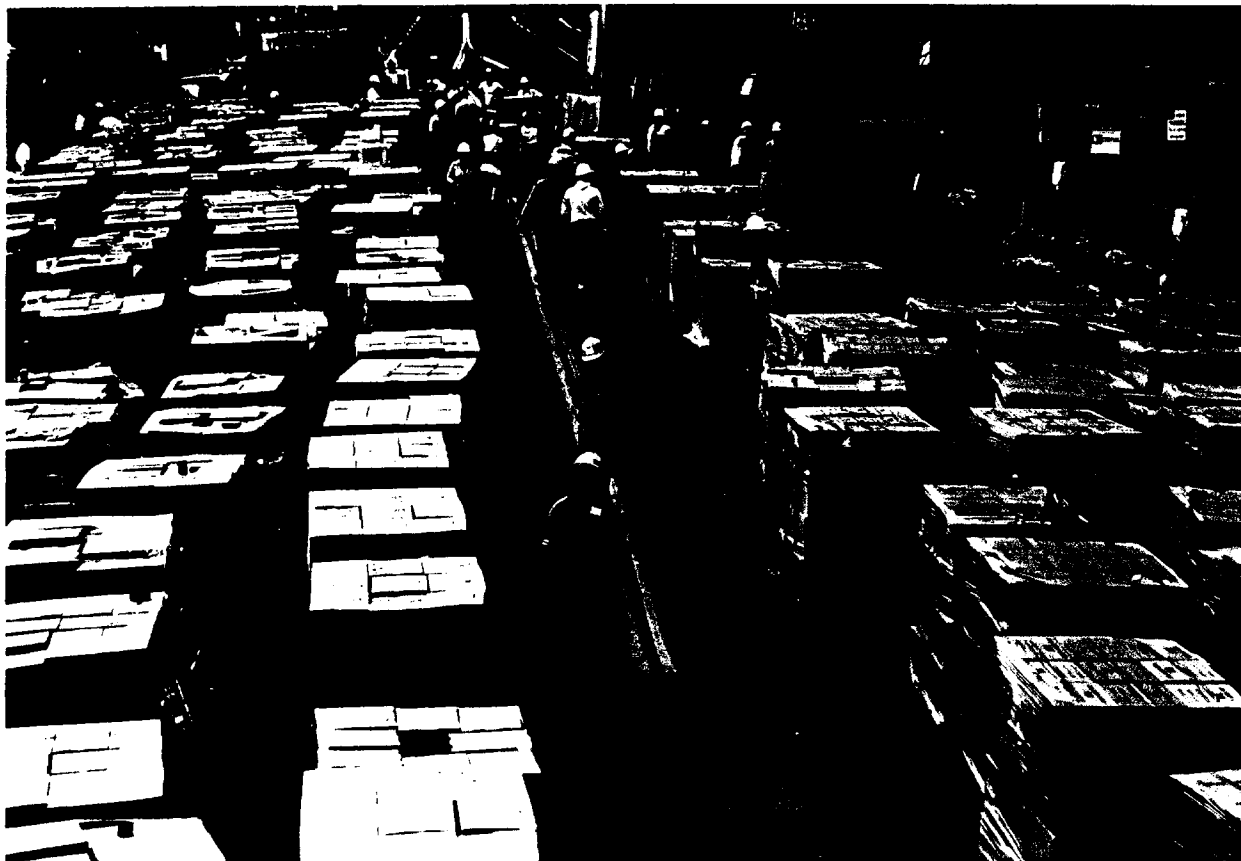
The columns have punch holes along their full length so brackets that support bookshelves may be attached (see Photo 2). Even though the shelf height is adjustable, there are normally seven or eight shelves (3 feet long and 8 inches deep) between columns at all tier levels. Most shelves were filled to capacity so fuel loading in the book stacks is estimated at 93 lbs. per square foot.

Photo 2  
Framework which Supports Walkways and  
Bookshelves in Stack Area. Credit: NFPA
